DEPARTMENT OF TRANSPORTATION**DIVISION OF ENGINEERING SERVICES**

Quality Assurance and Source Inspection

Contract #: 04-0120F4Cty: SF/ALA Rte: 80 PM: 13.2/13.9File #: 1.28**WELDING INSPECTION REPORT****Resident Engineer:**Siegenthaler, Peter**Address:** 333 Burma Road**City:** Oakland, CA 94607**Report No:** WIR-024367**Date Inspected:** 14-Jun-2011**Project Name:** SAS Superstructure**OSM Arrival Time:** 700**Prime Contractor:** American Bridge/Fluor Enterprises, a JV**OSM Departure Time:** 1930**Contractor:** American Bridge/Fluor Enterprises, a JV**Location:** Job Site**CWI Name:** See Report Below**CWI Present:** Yes No**Inspected CWI report:** Yes No N/A**Rod Oven in Use:** Yes No N/A**Electrode to specification:** Yes No N/A**Weld Procedures Followed:** Yes No N/A**Qualified Welders:** Yes No N/A**Verified Joint Fit-up:** Yes No N/A**Approved Drawings:** Yes No N/A**Approved WPS:** Yes No N/A**Delayed / Cancelled:** Yes No N/A**Bridge No:** 34-0006**Component:** Orthotropic Box Girders & Tower**Summary of Items Observed:**

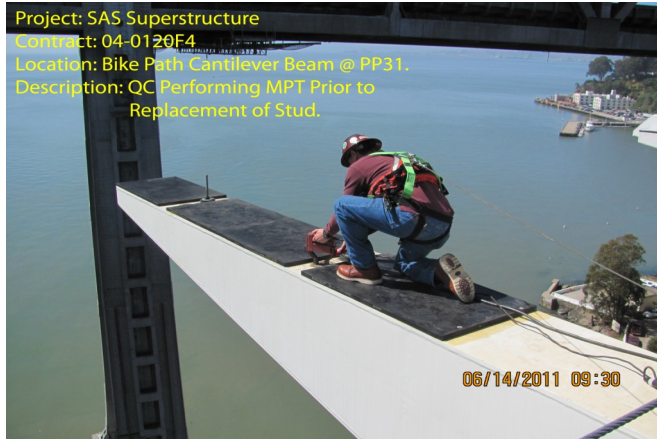
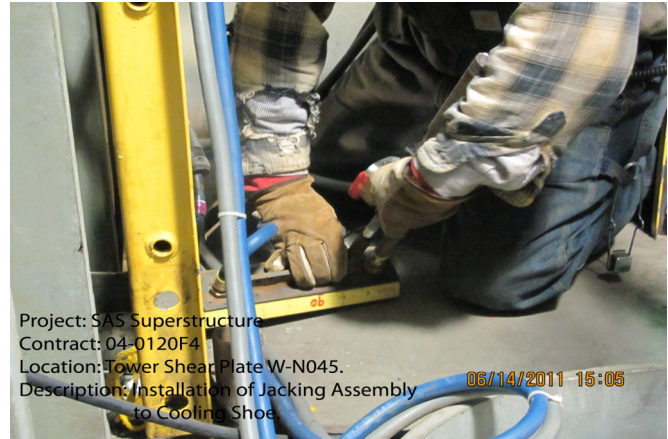
The digital photographs on page 3 of this report illustrate some of the work observed during this scheduled shift.
